August 8, 2019

**Subject: Environmental Inspection Report
144 Seekonk Street
(Assessors' Map 23, Block 76, Lot 71)**

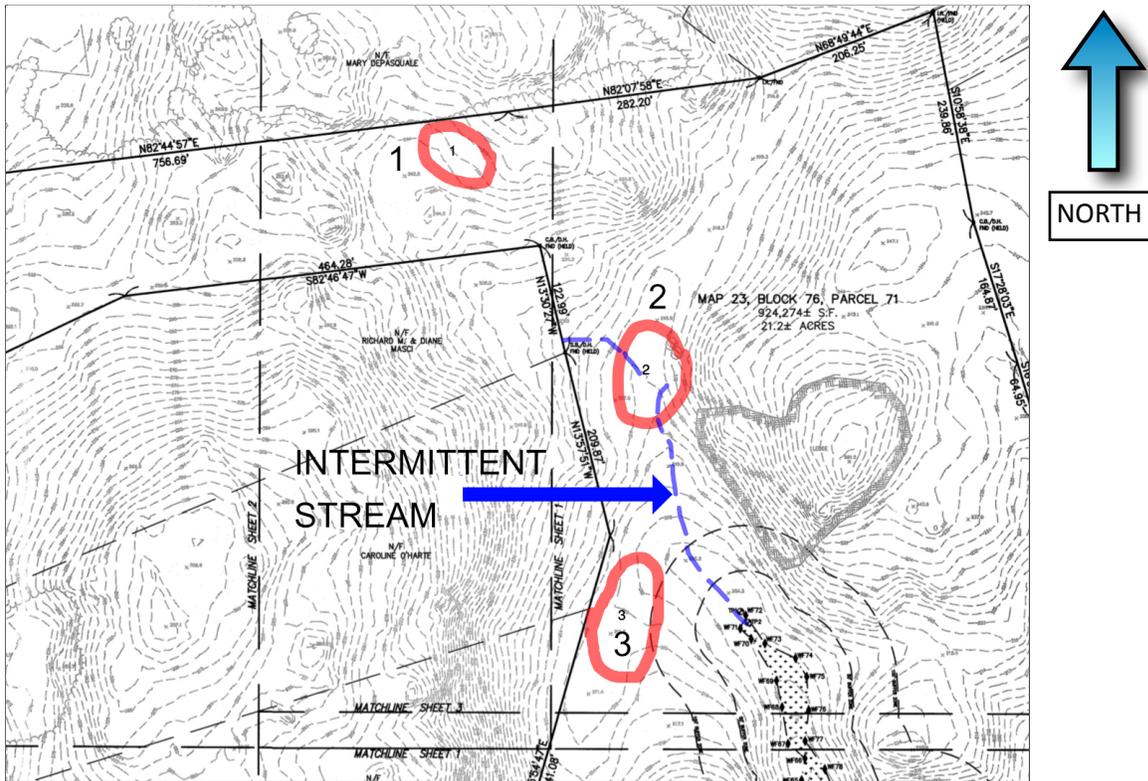
Figure 1. Areas in red were observed for potential wetland impacts and/or missing resources (base map from Andrews ANRAD plan, 12/1/17).

Figure 1 indicates areas that I identified in my February 19, 2018 Peer Review for the Zoning Board of Appeals (ZBA) as being wetlands potentially impacted by pre-2018 activities. I have labeled those areas

- 1 (the most northerly area),
- 2 (central location) and
- 3 (southerly).

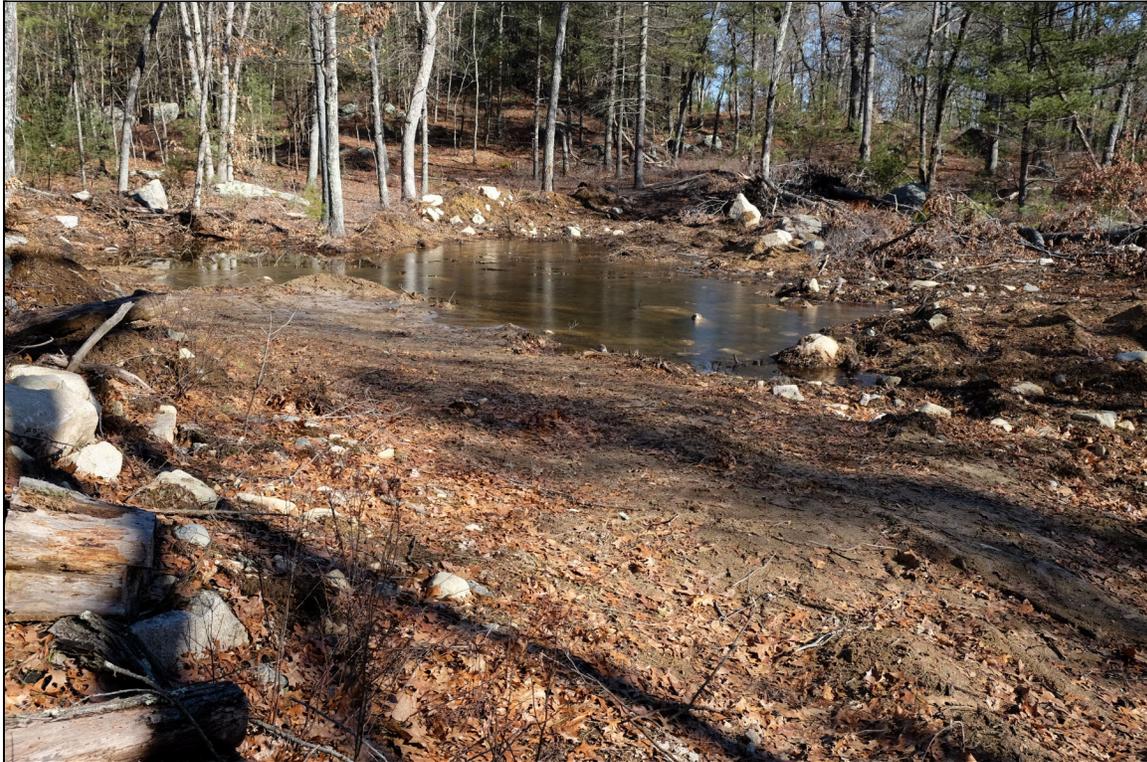
During my February 2018 site walk I found Area 1 to have been recently excavated and containing standing water. Newly excavated soils were exposed; there was no evidence of topsoil accumulation; and there was no old or emerging vegetation. These factors indicated clearing activities had occurred within the last 12 to 18 months.

Figure 2. Area 1, as observed in February 2018. Note irregular shape of ponded area.

Area 1 may be protected by the Bylaw under 2.(1)(f), as an area subject to inundation by surface or groundwater. It is not protected as a resource area under the state WPA. In addition, it does not meet the Bylaw definitions for Land Subject to Flooding or Pond.

That said, I note also that prior to excavation, Area 1 may have existed as a freshwater wetland protected by the Bylaw under 2.(1)(a). Excavation may have removed previously existing hydric soils and wetland vegetation from Area 1. From my observations, hydric soil is presently forming and a portion of the emergent vegetation in the excavated areas is comprised of wetland species.

In Massachusetts, hydric soils and wetland vegetation are typically found in the first 12-24-inches of soil. Excavation to depths below 24-inches would have removed evidence of hydric conditions. My professional opinion is that excavation in 2018 may have exceeded depths of 24-inches.

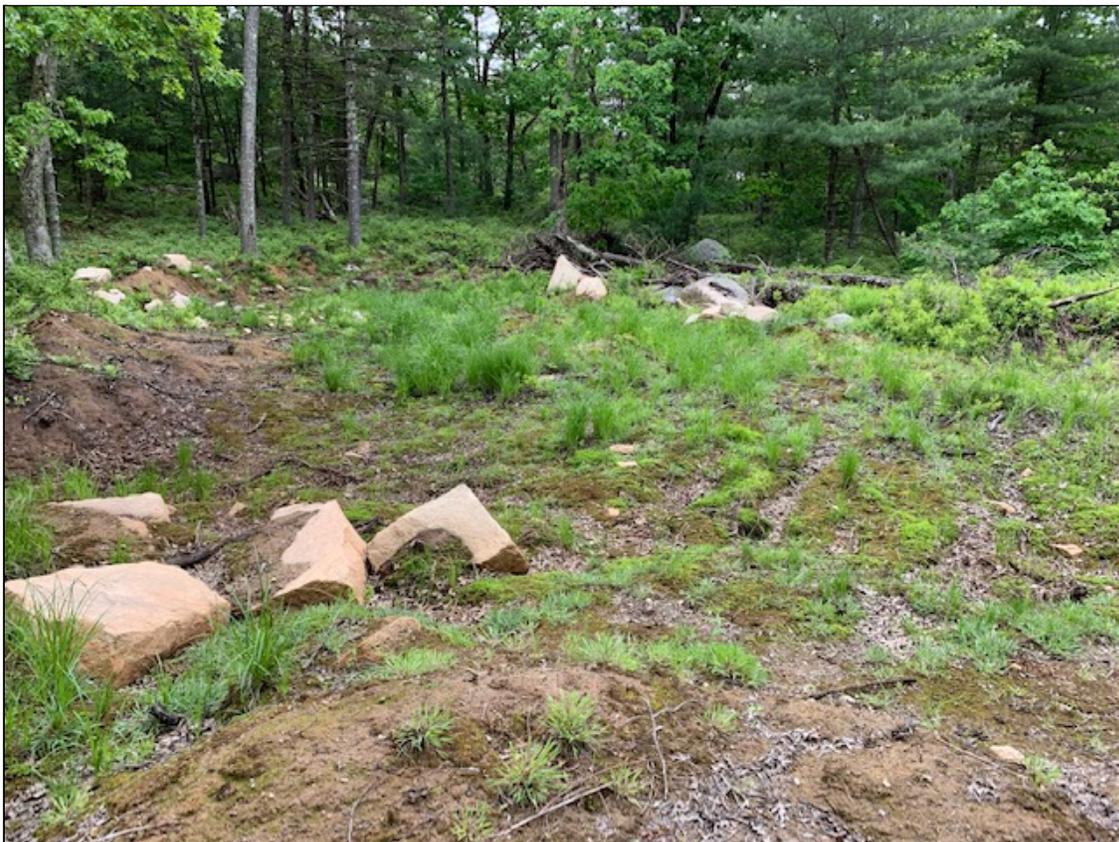
During my May 2019 site visit I found the same area to be dry. This variability is characteristic of an ephemeral pond.

Figure 3. Area 1 as observed in May 2019. Note emergent FACW grasses and sedges.

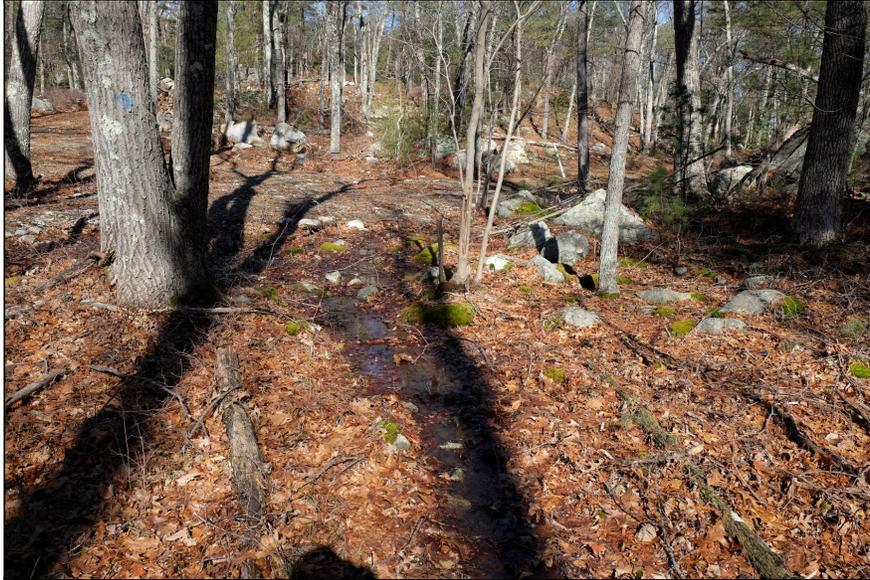
From my observations in both 2018 and 2019, during which I found the stream flowing (2018) and dry (2019)--and my observations that the stream has either banks or scouring along a definable hydraulic gradient from the upper reach at Area 2 to the wetland points IVW A-E, I conclude the stream is intermittent and as such, is protected under the Bylaw under 2.(1)(c). See 2018 photograph of stream below.

Figure 5. February 2018 shot of intermittent stream looking upgradient. Note stream terminates in upper portion of photo at its intersection with a dirt road that runs left to right in photo.

As indicated in Figures 4 and 5, the intermittent stream channel weaves upgradient until it abruptly ends in the vicinity of Area 2 at the edge of the dirt road.

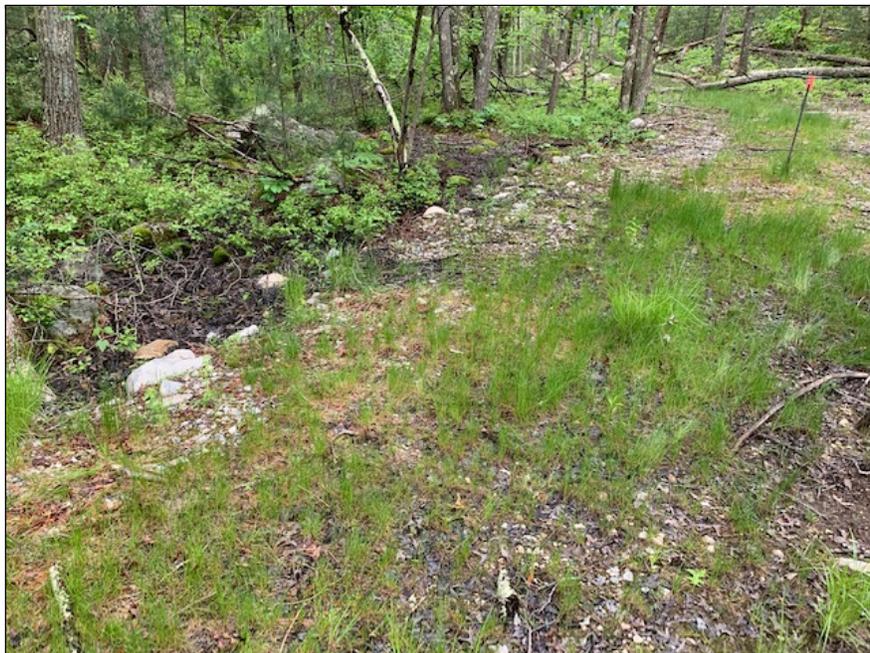
Figure 6. May 2019 photograph of intermittent stream at its intersection with dirt road. Stream is on left in darker area and dirt road is to its right where grassed area appears. The two areas

are physically separated by the small rocks and boulders shown.

A portion of the stream may have been filled during construction of the road in Area 2, thereby altering both WPA and Bylaw-protected Bank.

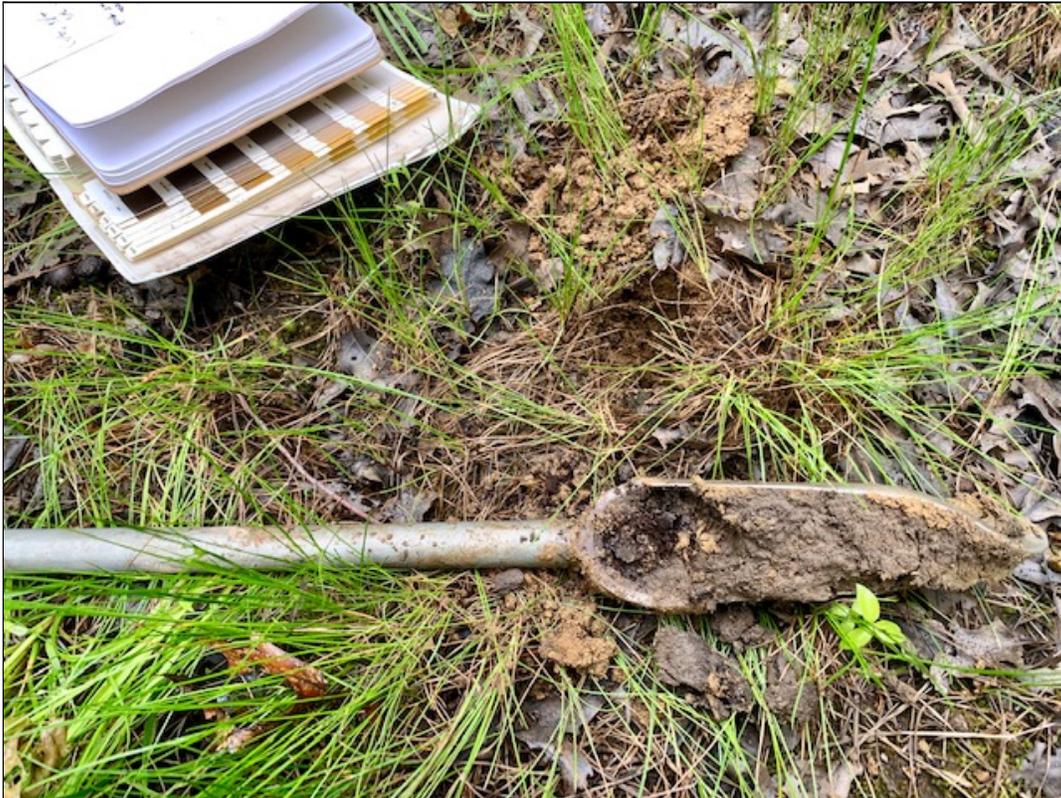
All eight holes revealed similar soil profiles. The top layer consisted of sand and gravels to depths of between nine and 13-inches; soil colors were indicative of upland soils (10YR 7/4 - 7/6), and showed no root formation.

Directly below the fill layer of all holes was an original organic top layer (technically designated an "Oe" horizon) which was four to six-inches deep. Colors varied between 10YR 3/1 and 3/2.

Directly below the organic top layer of all holes was an undisturbed mineral horizon (technically designated as an "A" horizon). Colors varied between 10YR 2/2 with greater than 10% redoximorphic (redox) activity, to 10YR 3/1 with less than 10% redox. Coloration of the "A" layer is indicative of hydric soils². Soil layer "A" textures were fine sandy loam.

Figure 7. May 2019 photograph of Hole A. Top of auger show Oe horizon; mid and end portions show A horizon (10YR 2/2 with >10% redox). The traces of brighter soil at end of auger are residue from the top fill layer.

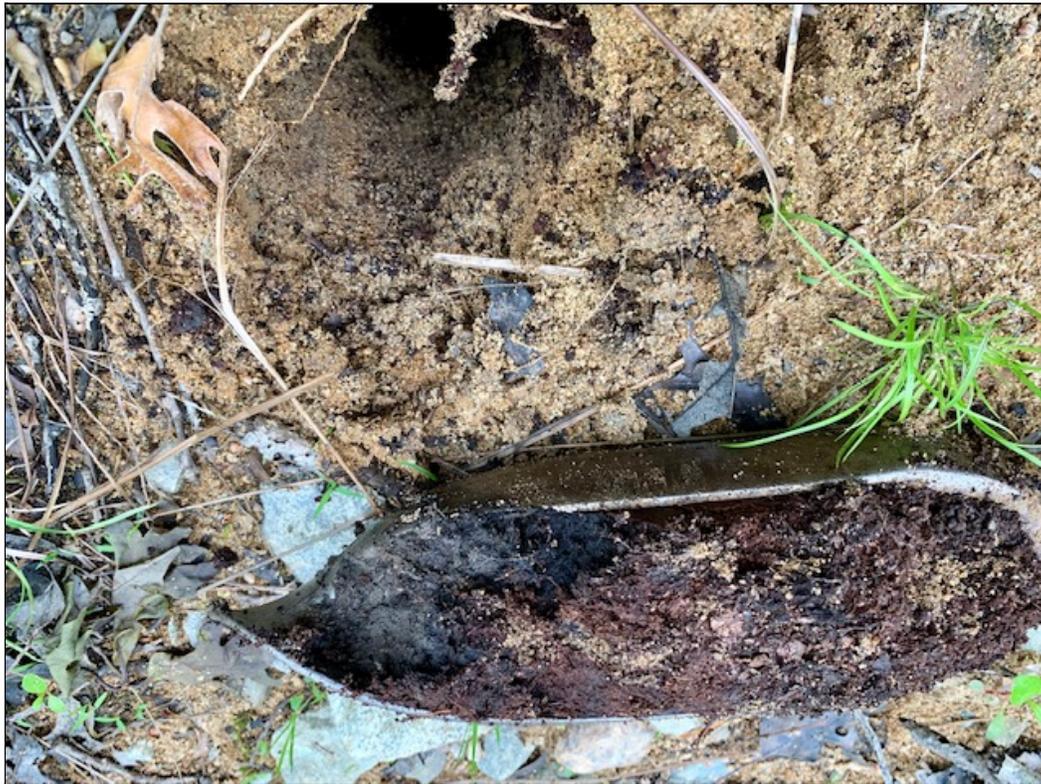
Figure 8. May 2019 photograph of Hole E. Top of auger (shown in lower left portion of photo) indicates Oe layer and tip of auger shows gleyed A layer (5BG 5/1).

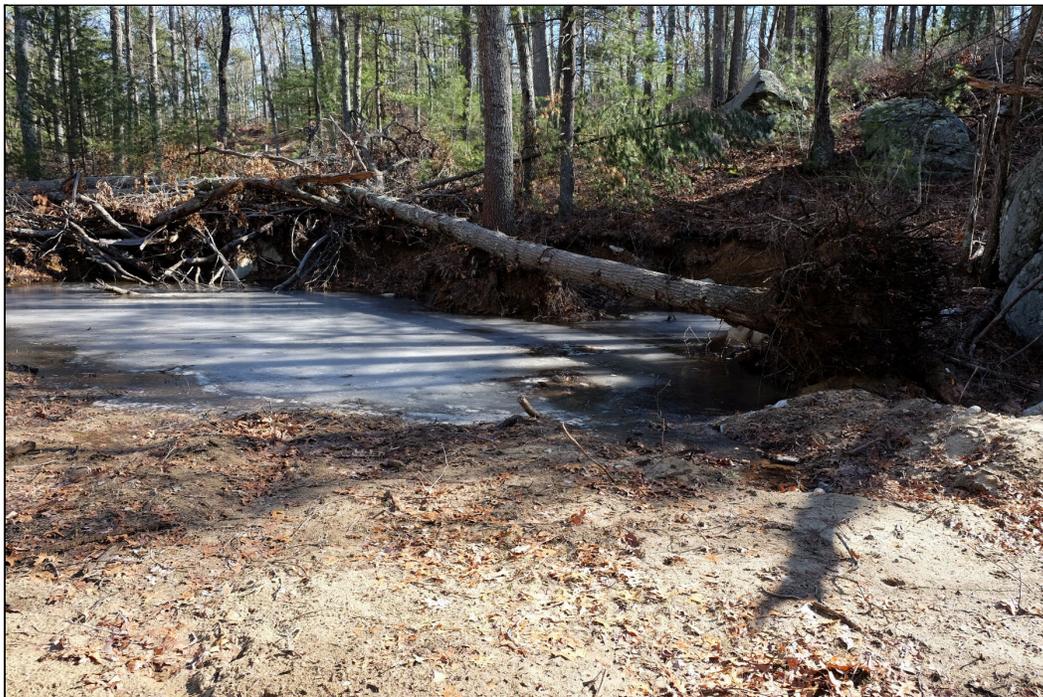
Also, within Area 2 at its highest point (the top and terminus of the intermittent stream), an area approximately 15 by 35-feet in size was excavated before my observation in 2018. It, like Area 1, ponds water periodically and may, prior to excavation, have connected to the intermittent stream. In its current state, it, like Area 1, is protected under the Bylaw under 2.(1)(f), as an area subject to inundation by surface or groundwater.

Figure 9. February 2018 photograph of ponded area described directly above. (See Figure 10

below for May 2019 shot of same area).

Similarly, the small flooded area shown in Figure 9 of Area 2 is protected in the Bylaw under 2.(1)(f), as an area subject to inundation by surface or groundwater. It, like Area 1, does not appear to be the result of Title 5 testing, as deep holes must be properly backfilled to original surface elevation.

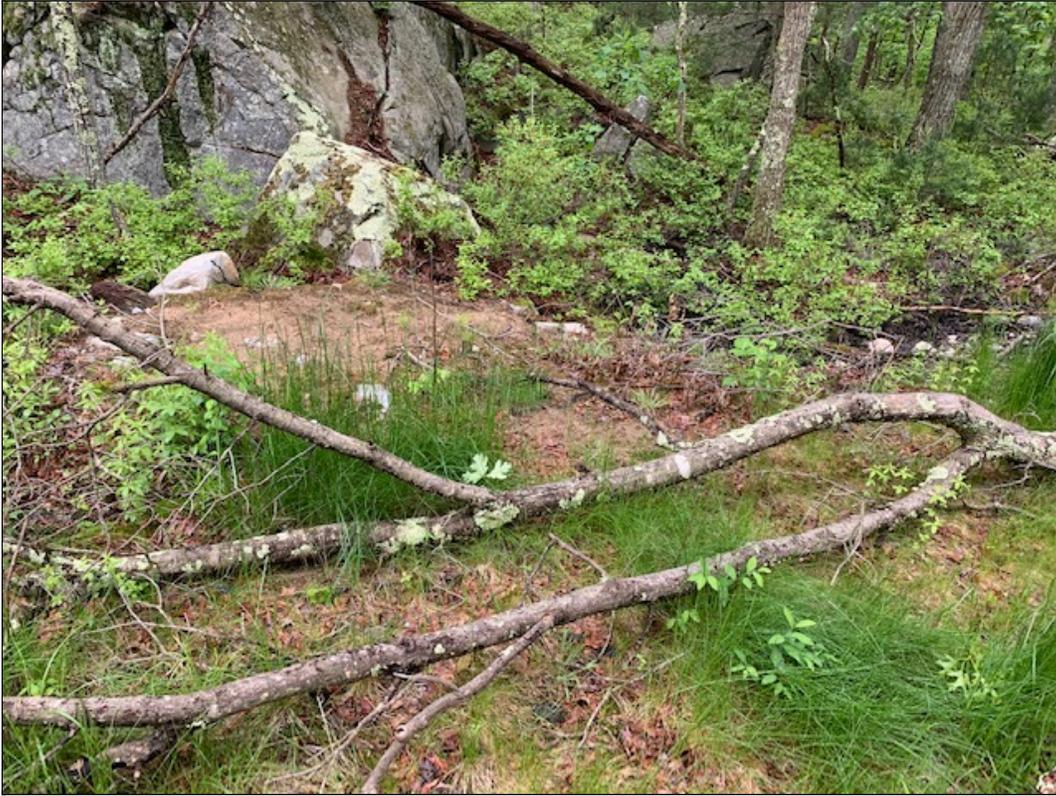
Figure 10. February 2018 photograph of same area, dry.

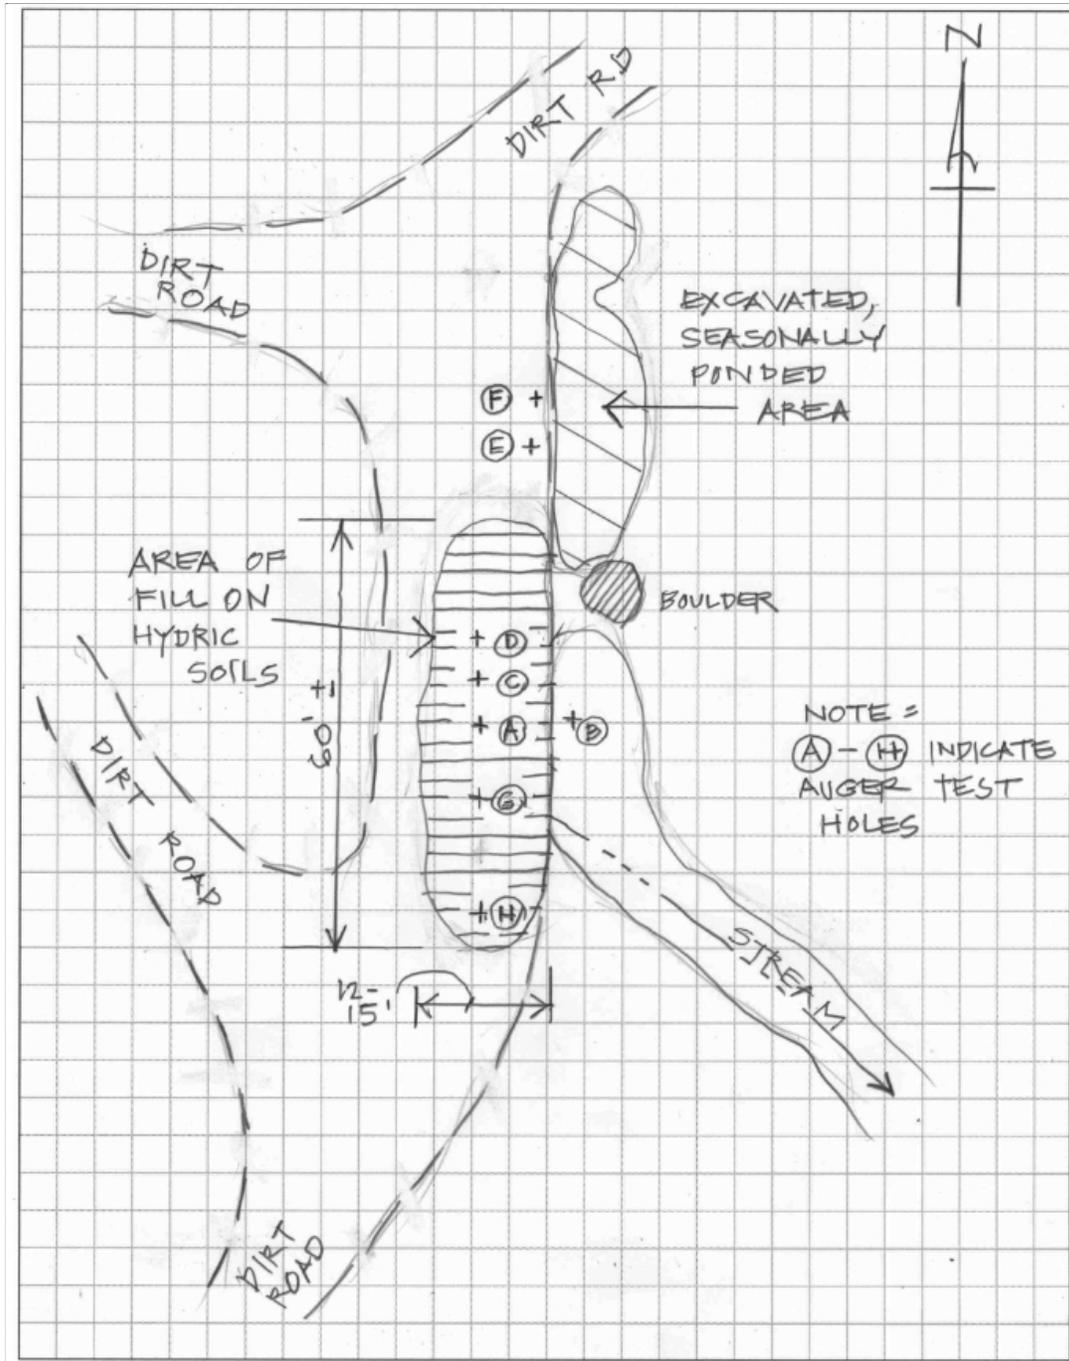
As shown in Figure 11 below, all the soil borings made in the area marked,

"Area of Fill on Hydric Soils" indicated wetland (hydric) soils underlying a new sand/gravel fill. Therefore, this area, before disturbance, was likely to be WPA-protected BVW (or as categorized in the Bylaw, a freshwater wetland). The ponded area shown in Figure 9 (also shown in Figure 11 as, "Excavated, Seasonally-Ponded Area") may have been part of that BVW. However, because of the excavation, no original soils exist and a conclusive determination could not be made.

Figure 11. Area 2: Sketch from May 2019 field notes. Note that the terminus of the stream at its intersection with the road edge occurs at approximately auger test hole #G (between A and H).

In addition, the location marked, "Area of Fill on Hydric Soils" on Figure 11 beside the stream (see Figure 11) is likely to have been both (1) state-protected BVW, and (2) Bylaw-protected freshwater wetland. This approximately 20 by 60-foot area contains wetland soils beneath nine and 13-inches of new sand/gravel fill. (I note that state-protected BVW is also federally-protected under the Clean Water Act.)
